Manhole Inspection Summary

Manhole # S25YY_024MH

Insp Date: **7/28/08 1:01 PM**

Location Address: **3300 CLIPPER MILL RD**

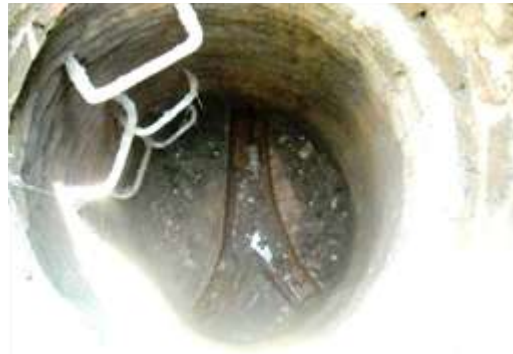
Top View

Evidence of surcharge - Bench debris.
Channel debris.

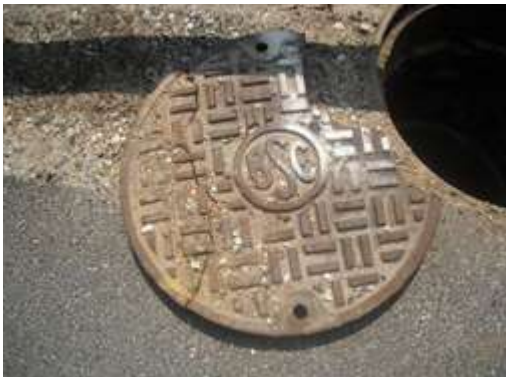
Broken lid

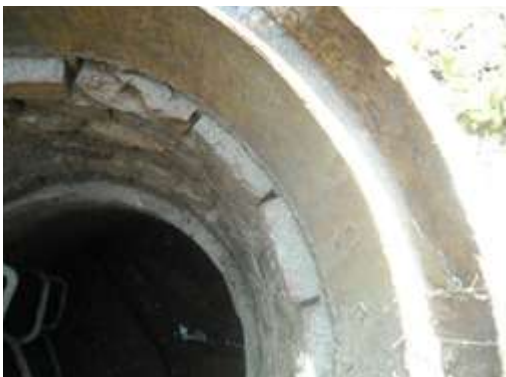
Defect

Frame leaks. Frame offset. Adjustment deterioration and infiltration. Corbel and Barrel infiltration.

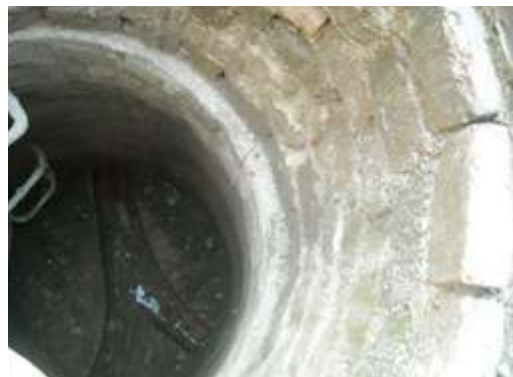
Defect

Frame leaks. Frame offset. Adjustment deterioration and infiltration. Corbel and Barrel infiltration - other side.

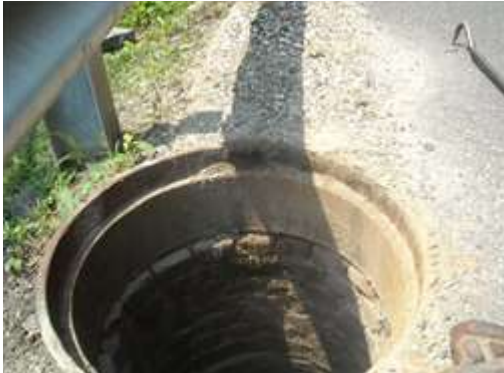
Defect

Frame leaks. Adjustment deterioration and infiltration.

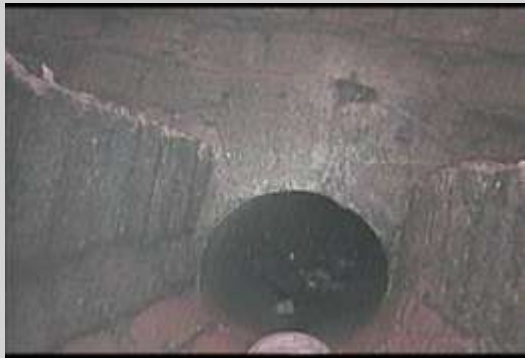
8 in. Circular Gravity Sewer Pipe Out @ 12 O'Clock

Infiltration: **None** Pipe Seal Cond: **Cracked**

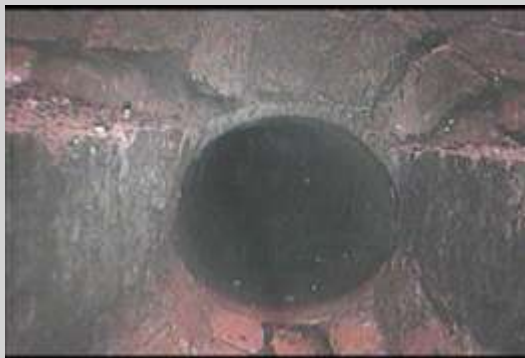
8 in. Circular Gravity Sewer Pipe In @ 5 O'Clock

Infiltration: **None** Pipe Seal Cond: **Cracked**

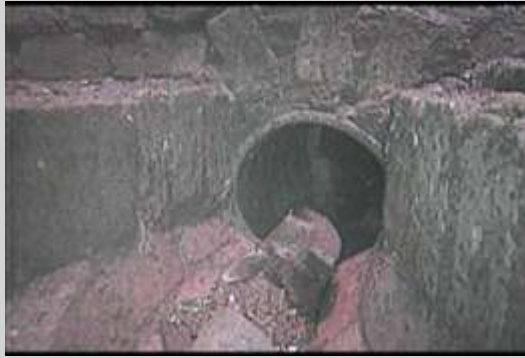
6 in. Circular Gravity Sewer

Deposits: ☐ None ☐ Mud ☐ Sludge ☒ **Debris** ☐ Grease

Silt Depth: **0** (in.) Deposits Extent: **Light**
